**Tilcon New Jersey
Riverdale Quarry
Quarterly Blast Compliance Summary
January through March 2021**

Comparison of Measured Blast Vibrations to Current U.S. Bureau of Mines Recommendations Tilcon New Jersey Pompton Lakes 1st Quarter 2021

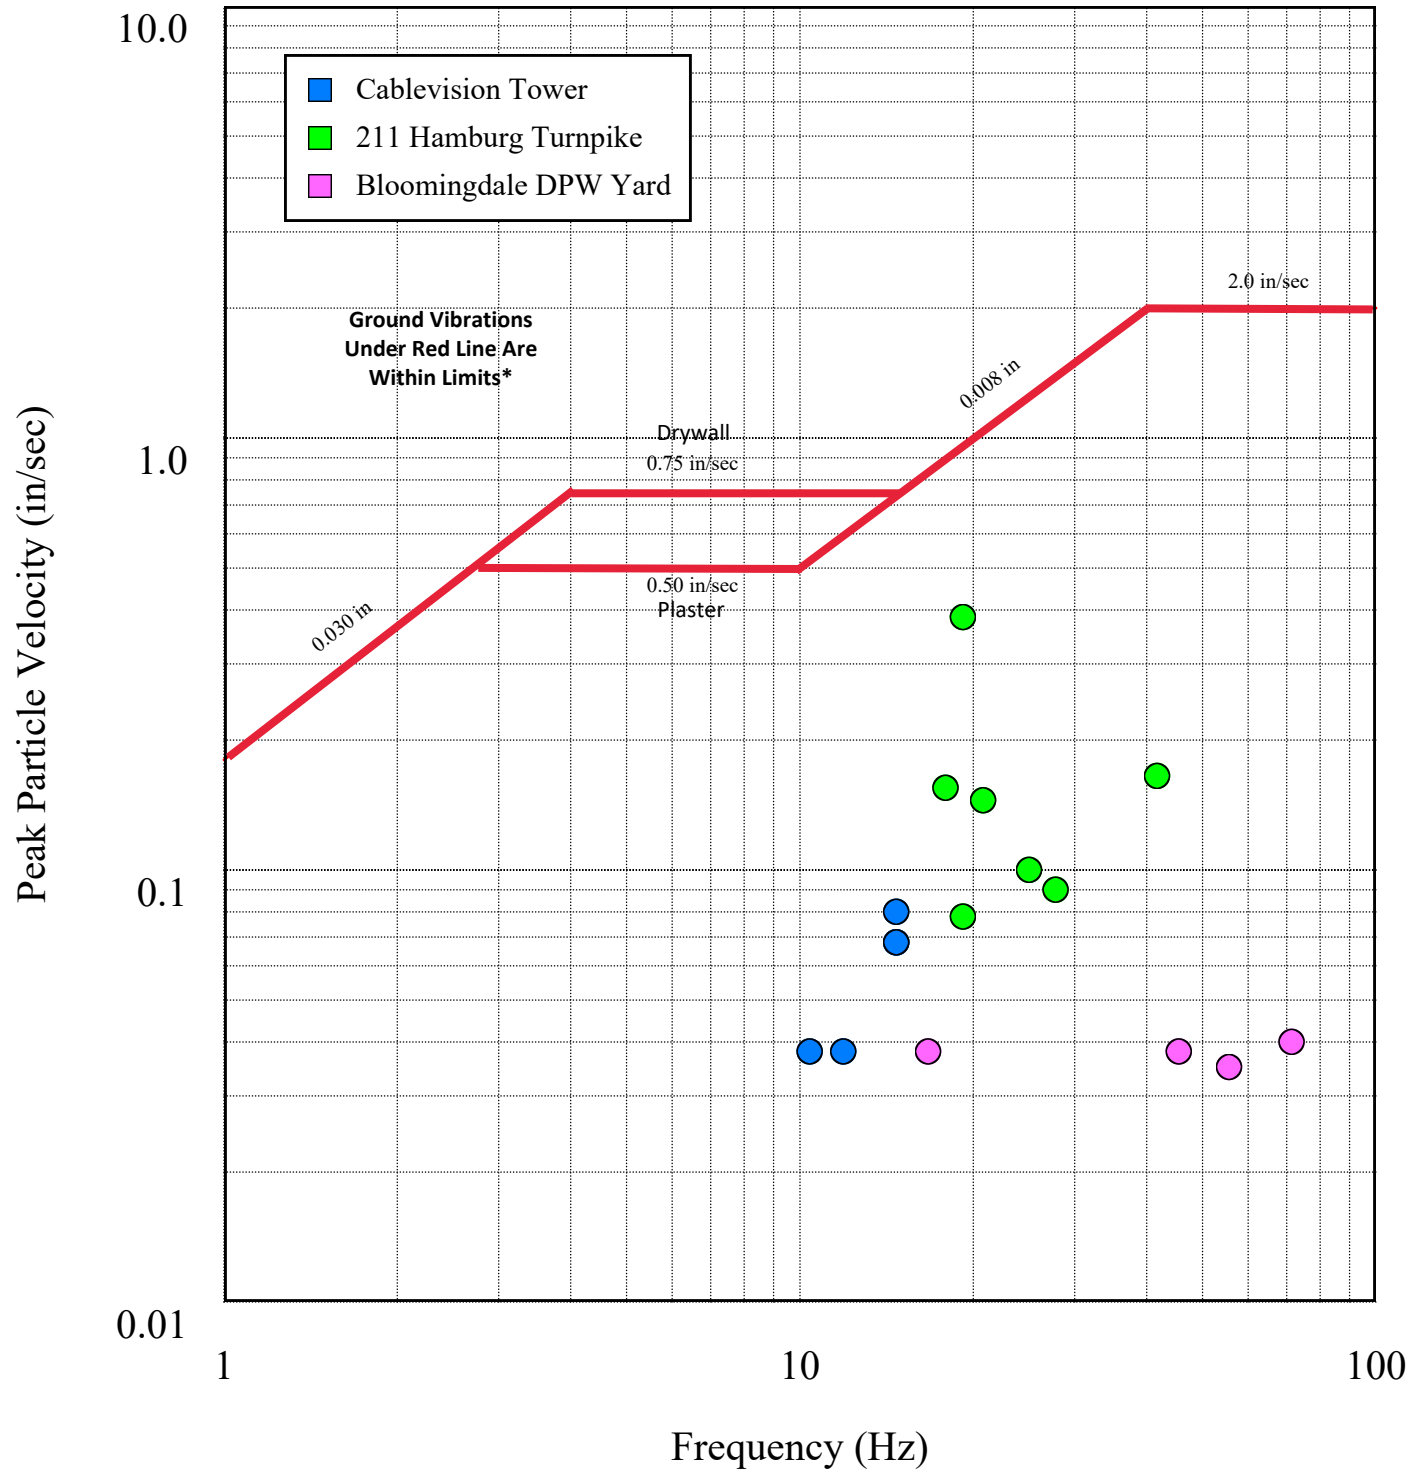
*As per State of New Jersey Administrative Code 12:190; Subchapter 7.26

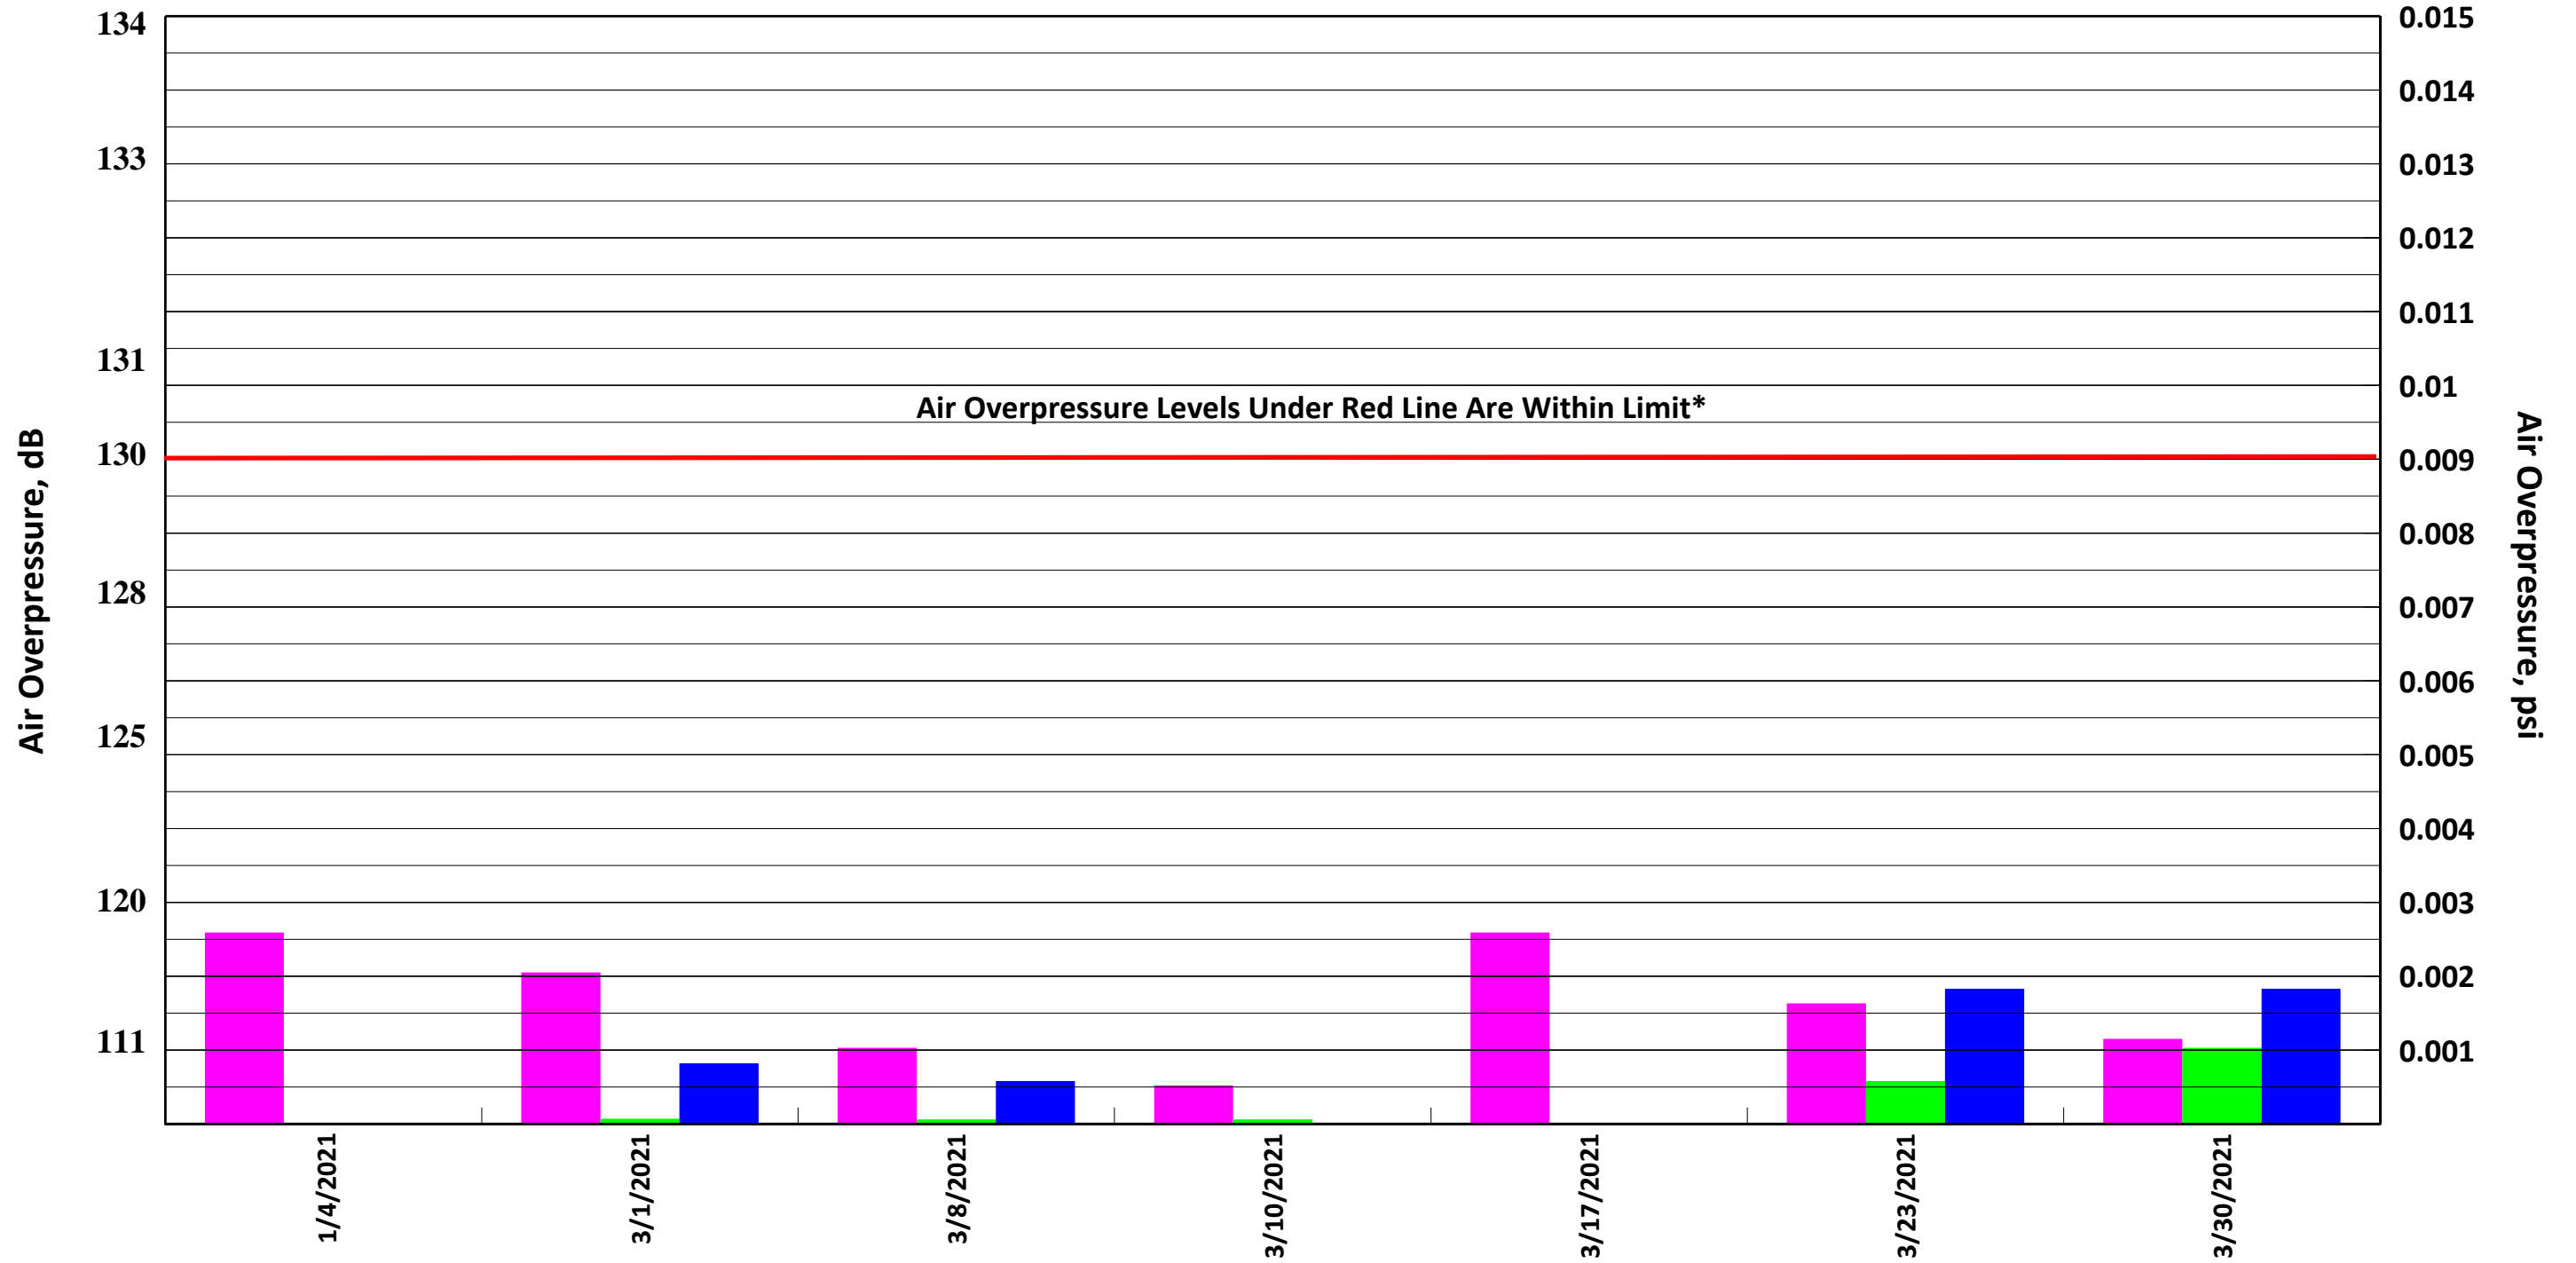
Air Overpressure Levels from Tilcon New Jersey - Pompton Lakes Quarry 1st Quarter 2021

*As per State of New Jersey Administrative Code Title 12.190; Subchapter 7.25

■ 211 Hamburg Turnpike
 ■ Cablevision Tower
 ■ Bloomingdale DPW Yard
